BRANDYWINE CREEK
NEW CASTLE COUNTY, DELAWARE

PREPARED FOR THE NEW CASTLE COUNTY DEPARTMENT OF PLANNING
BY CORPS OF ENGINEERS, U.S. ARMY PHILADELPHIA DISTRICT

JULY 1973

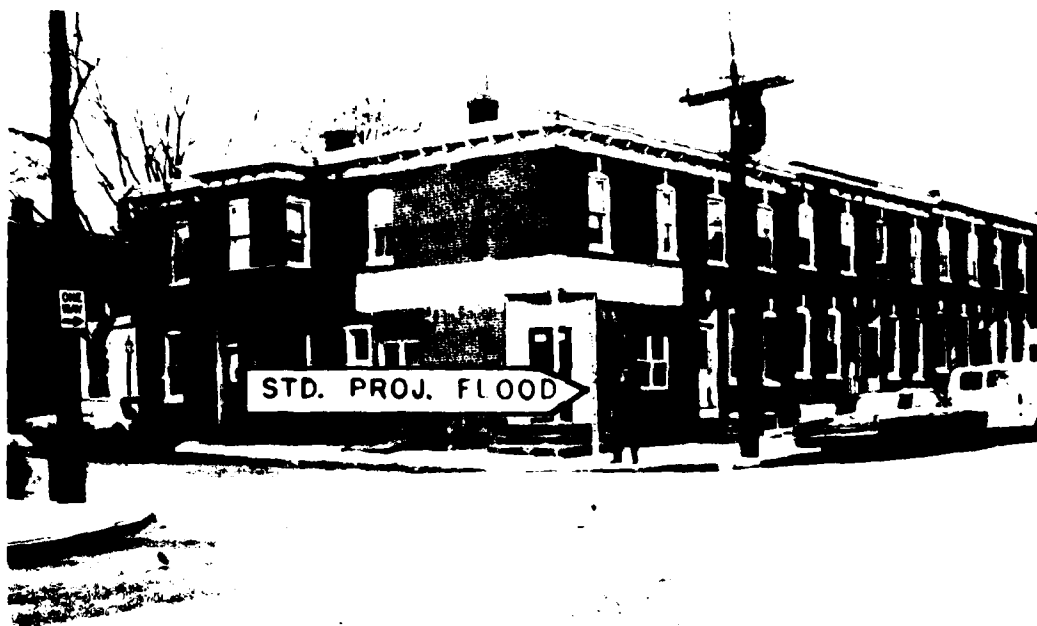
FIGURE 4 - Future flood height at the intersection of Bennett and 11th Streets.

Photographs, future flood heights - The levels that the Intermediate Regional and Standard Project Floods are expected to reach at various locations along Brandywine Creek are indicated on the following photographs.

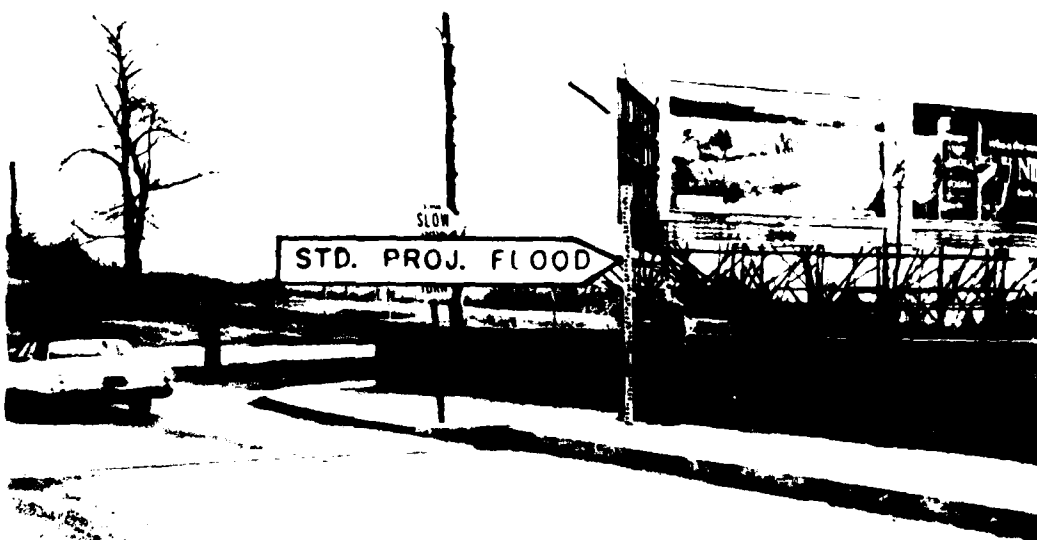
FIGURE 5 - Future flood height at Jessup Street bridge.

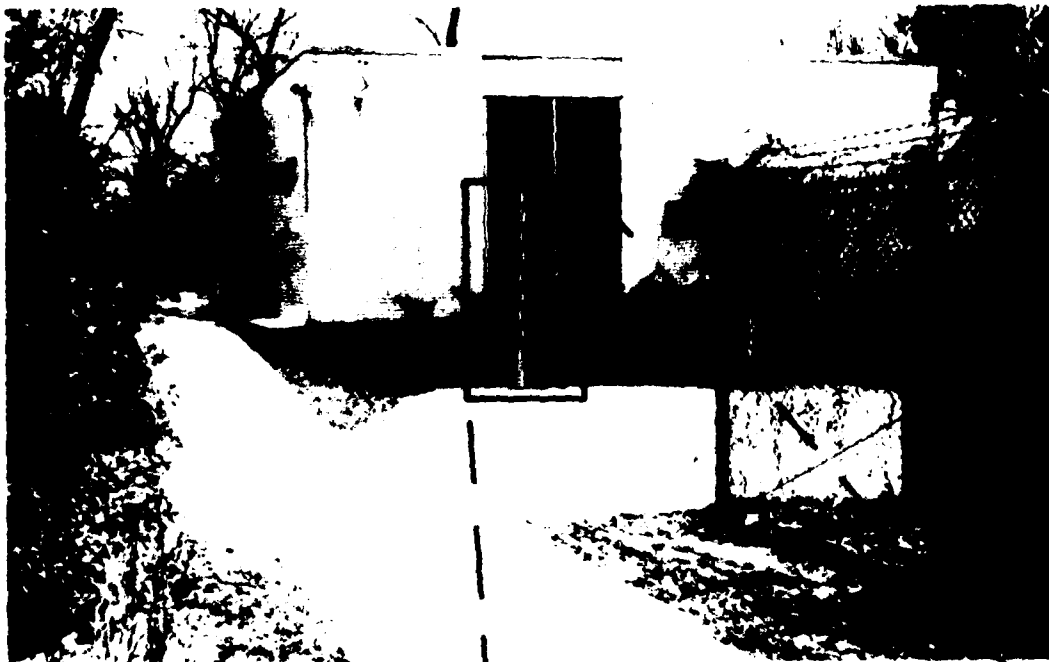
FIGURE 6 - Future flood heights at the Wilmington Water Department's pumping station just downstream of Union Street bridge. The Standard Project Flood would be 6.6 feet above the top of the rod.

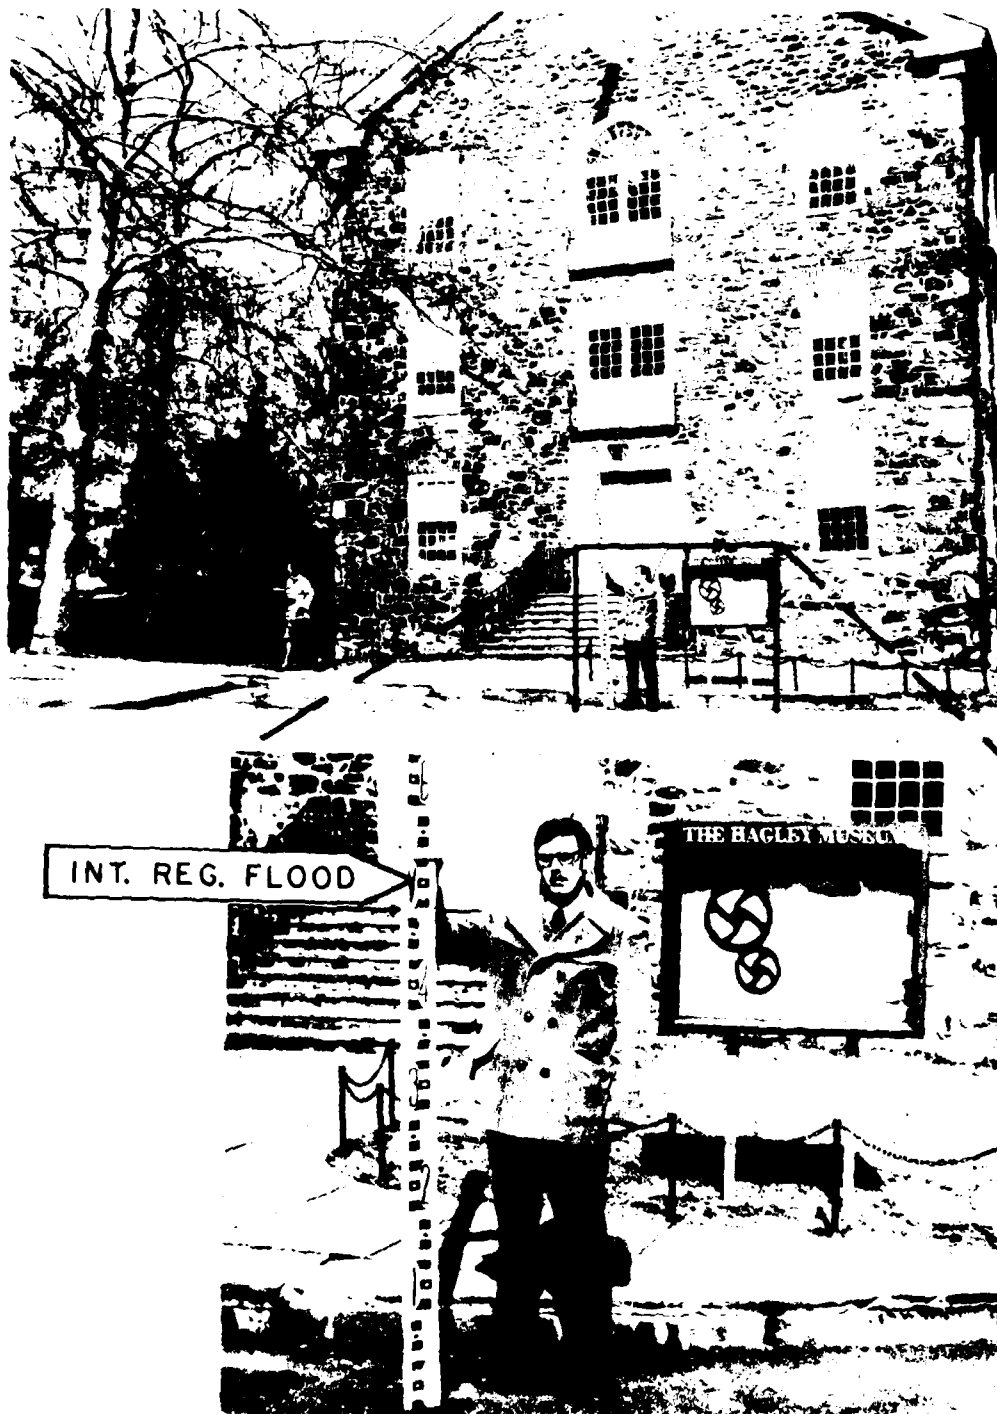
FIGURE 7 - Future flood heights at Hagley Museum. The Standard Project Flood would be 5.8 feet above the top of the rod.

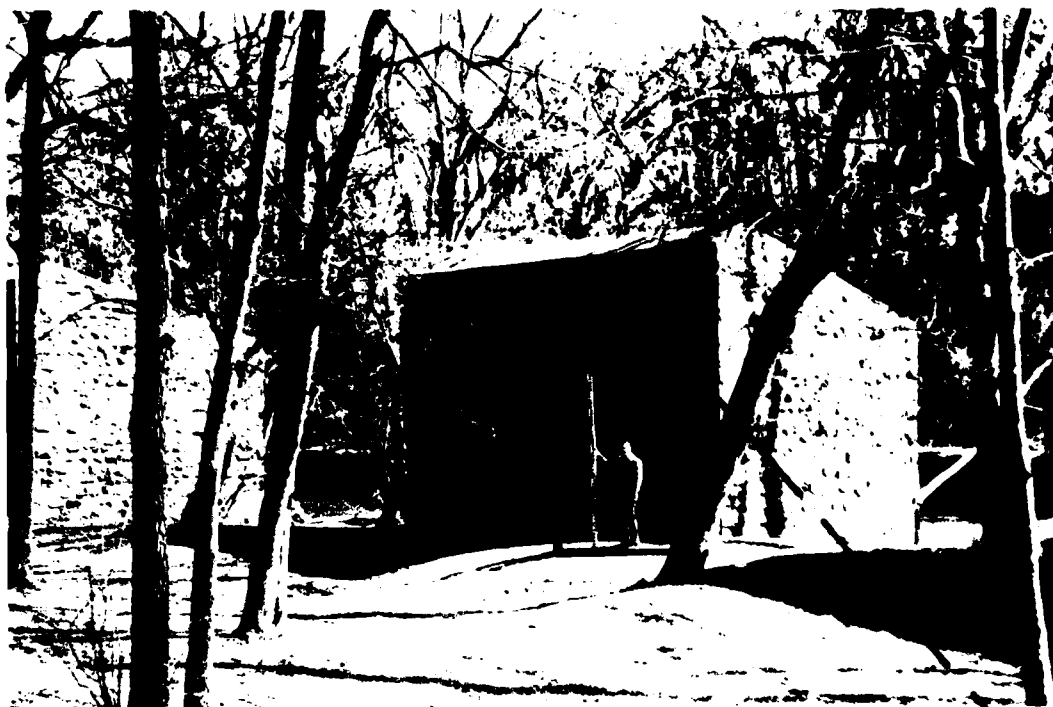
FIGURE 8 -

Future flood heights at Hagley Museum's Gunpowder Mills. The Standard Project Flood would be 7.0 feet above the top of the rod.

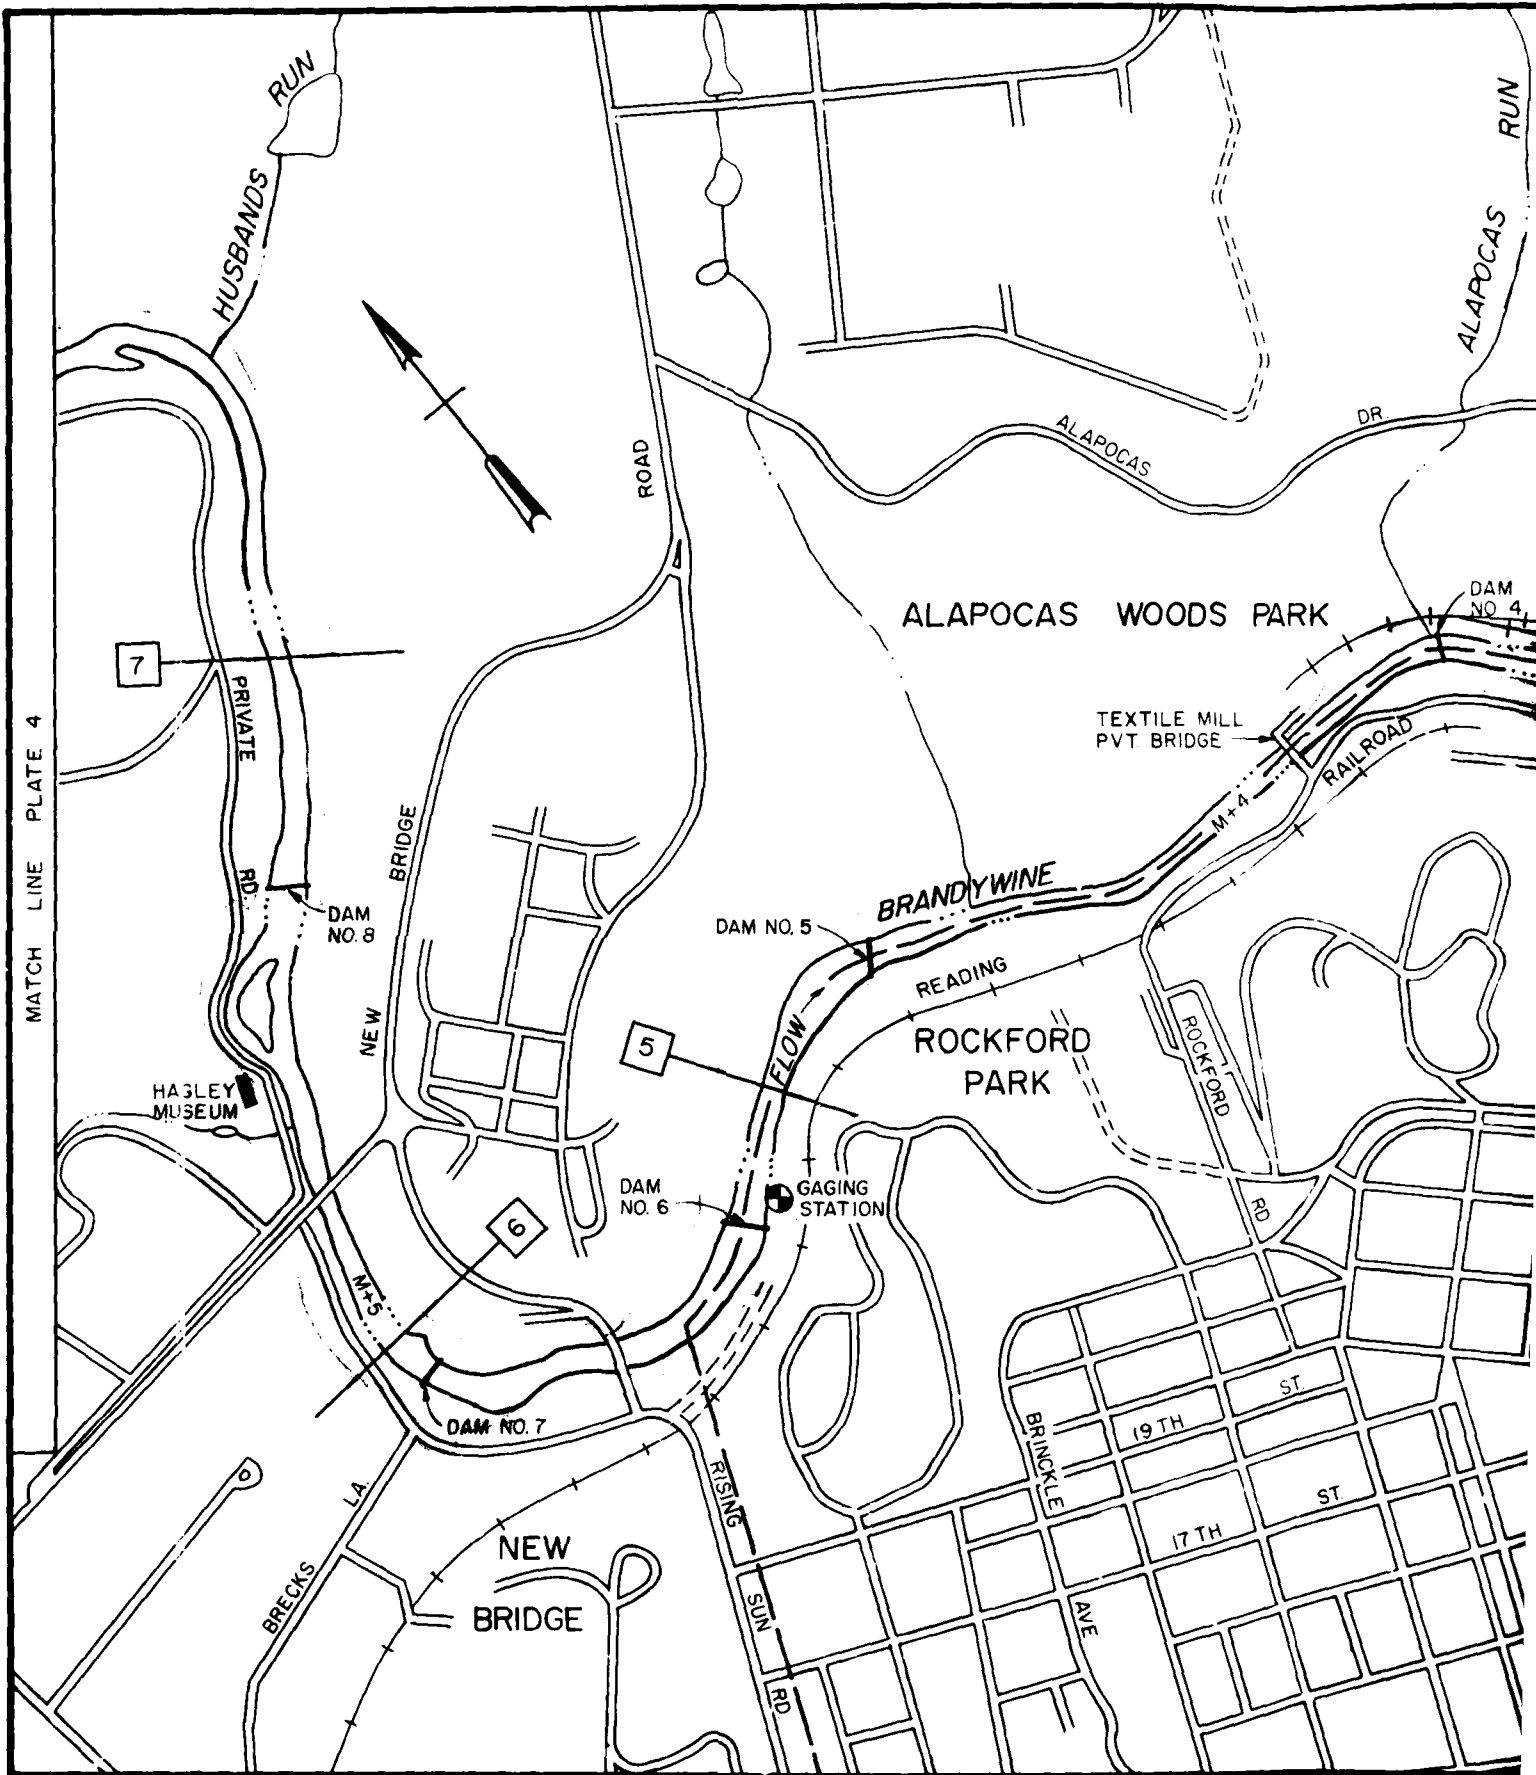
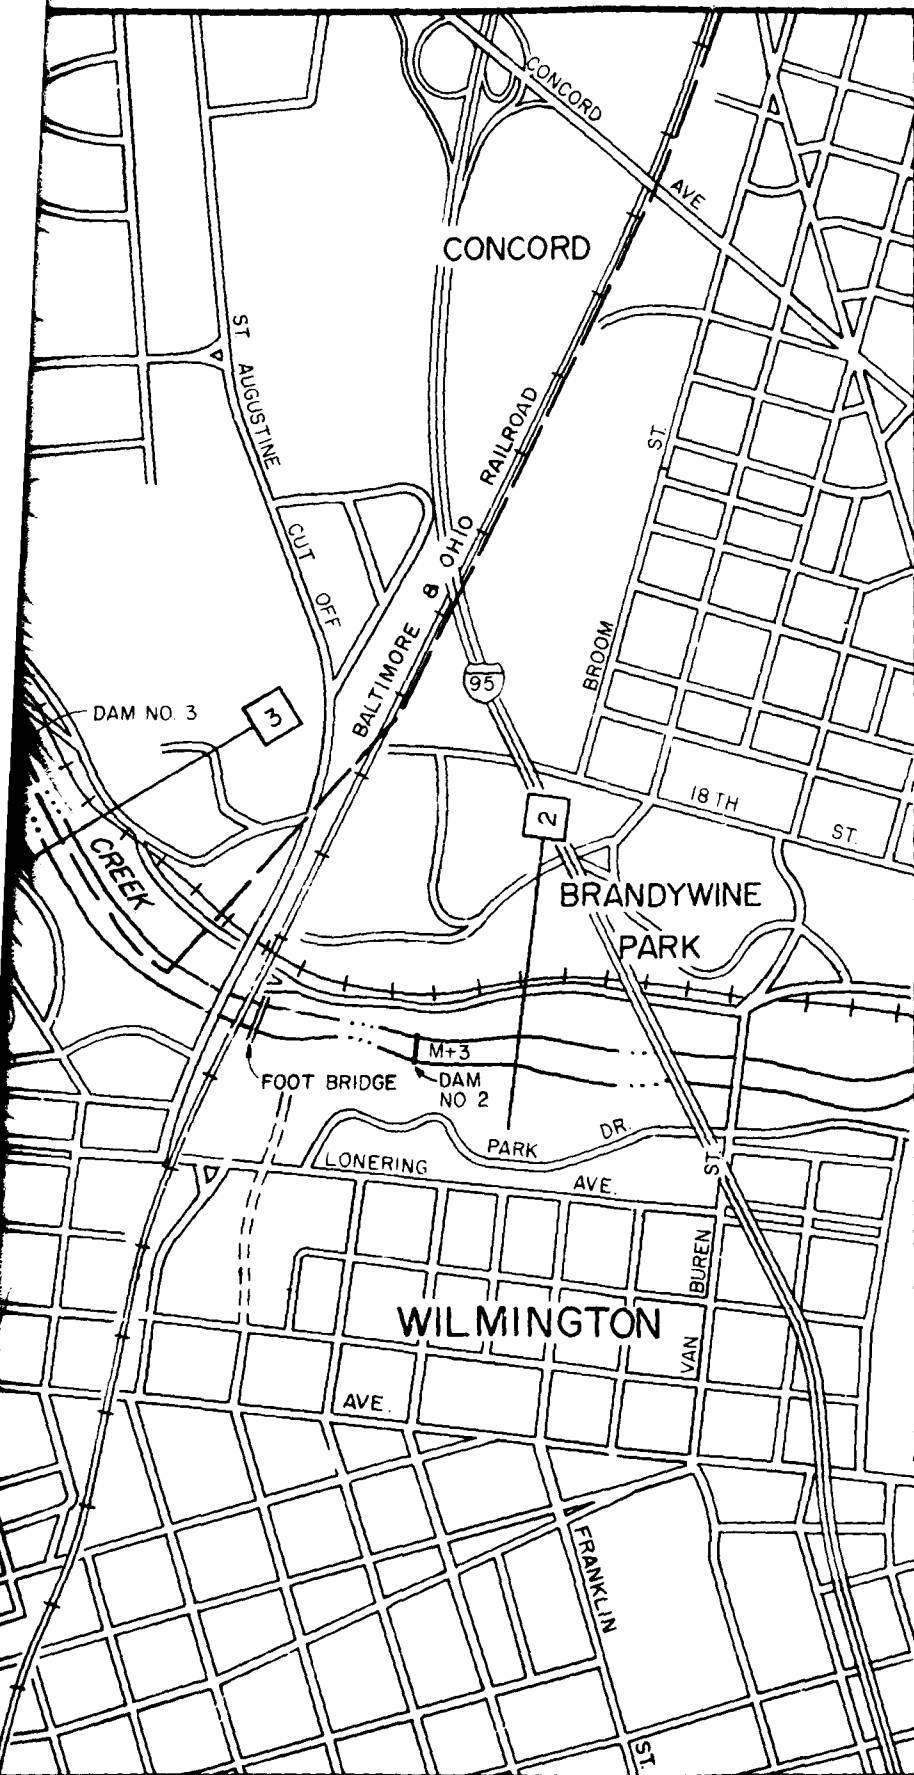
PLATE 4

FLOODED AREAS

Flooded areas and flood damages - The areas along the study reach of Brandywine Creek that would be flooded by the Standard Project Flood are shown on Plate 2, which is also an index map to Plates 3 through 6. Areas that would be flooded by the Intermediate Regional Flood and the Standard Project Flood are shown in detail on Plates 3 through 6. The actual limits of these overflow areas may vary somewhat from those shown on the maps because the 10-foot contour interval and scale of the maps do not permit precise plotting of the flooded area boundaries. As may be seen from these plates, floodflows from the main stem of Brandywine Creek inundate Wilmington and other small communities adjacent to the stream. The areas that would be flooded by the Intermediate Regional and Standard Project Floods include commercial and residential properties, along with associated streets and roads. Considerable damage to the facilities would occur during an Intermediate Regional Flood. However, due to the wider extent, greater depths of flooding, higher velocity flow and longer duration of flooding during a Standard Project Flood, damage would be more severe than during an Intermediate Regional Flood. Plates 7 and 8 show the water surface profile for the Intermediate Regional and Standard Project Floods. Plates 9 and 10 show the water surface profile for the same floods as modified by the proposed Soil Conservation Service Dams. Depth of flow in the channel can be estimated from these illustrations. Cross sections of the flood plain at selected locations, together with the water surface elevation and lateral extent of the Intermediate Regional and the Standard Project Floods are shown on Plate 11.

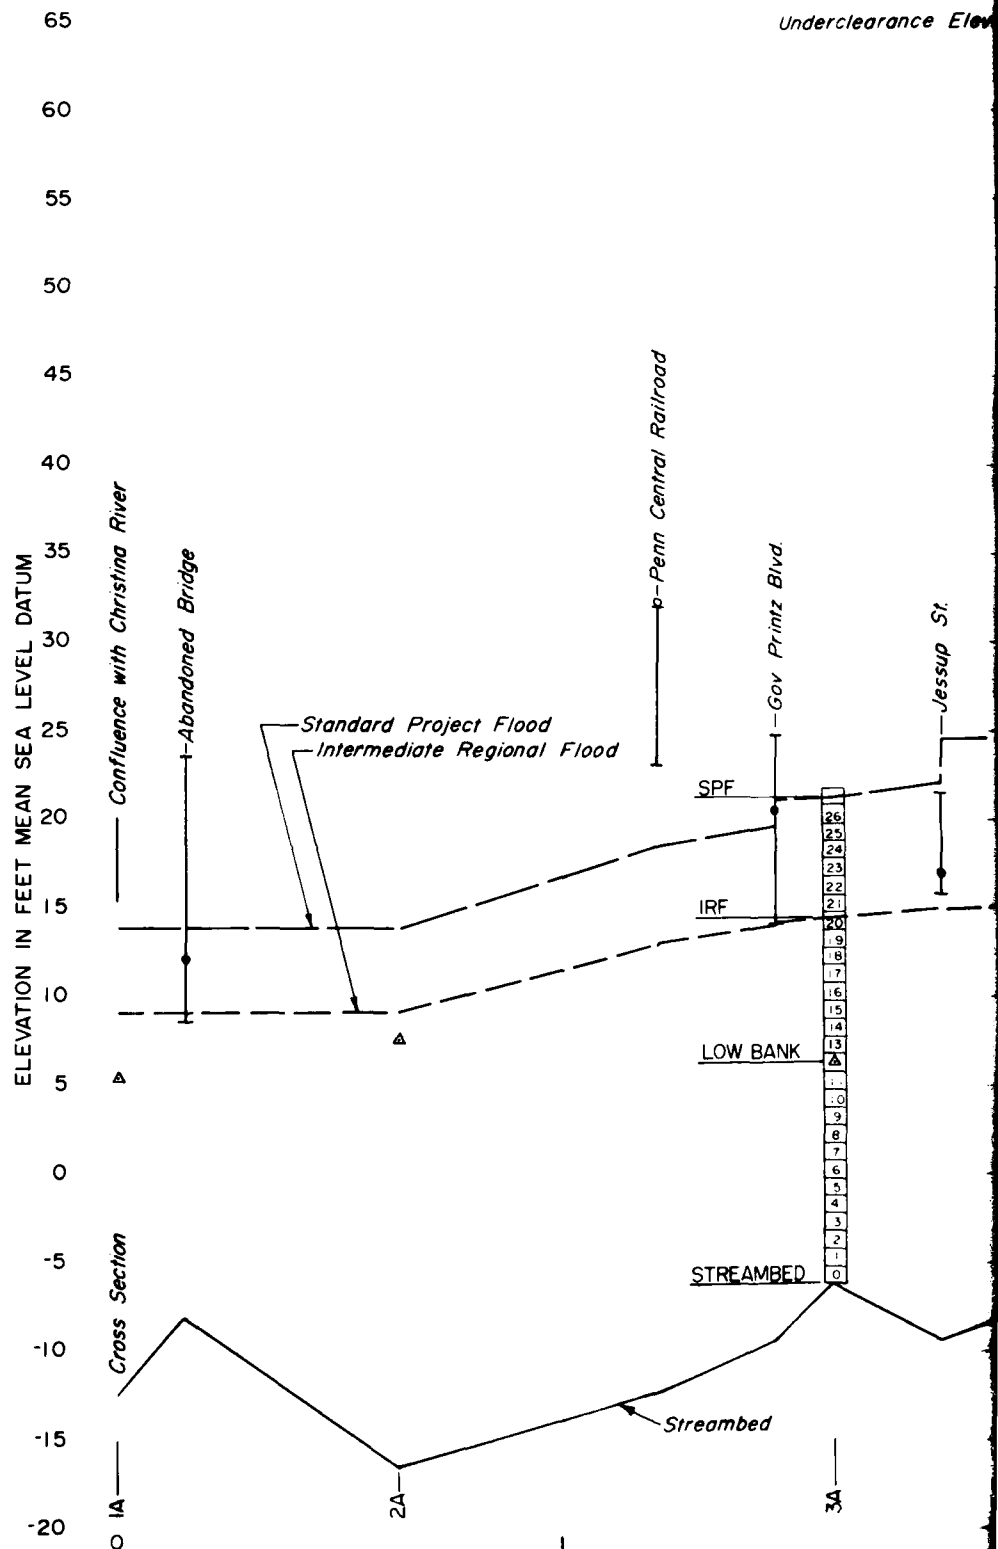
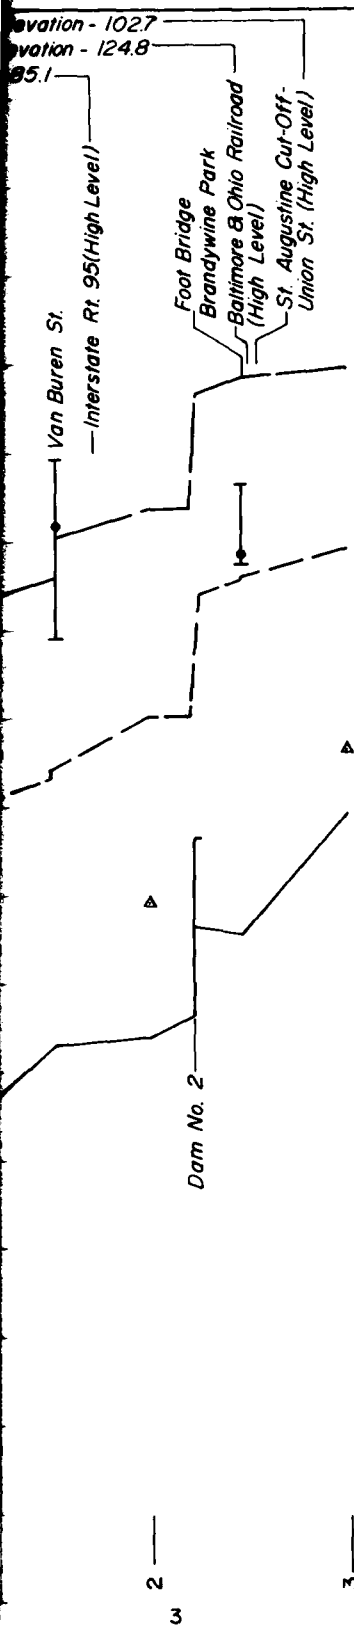
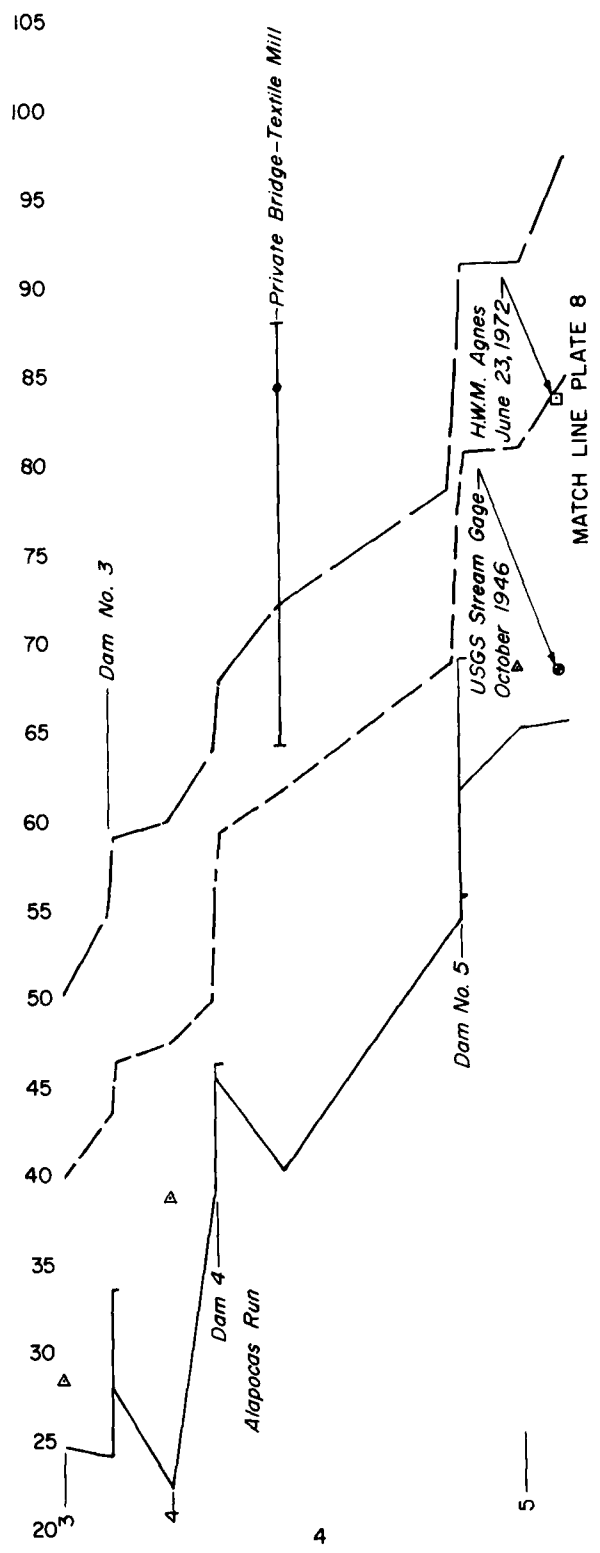
Stationing of natural streambed for Brandywine Creek begins along the projection of the left bank of Christina River at the confluence with Brandywine Creek

DEPARTMENT OF THE ARMY
 PHILADELPHIA DISTRICT, CORPS OF ENGINEERS
 PHILADELPHIA, PENNSYLVANIA
 FLOOD PLAIN INFORMATION
 BRANDYWINE CREEK
 NEW CASTLE COUNTY
DELAWARE
 HIGH WATER PROFILES
 JULY 1973

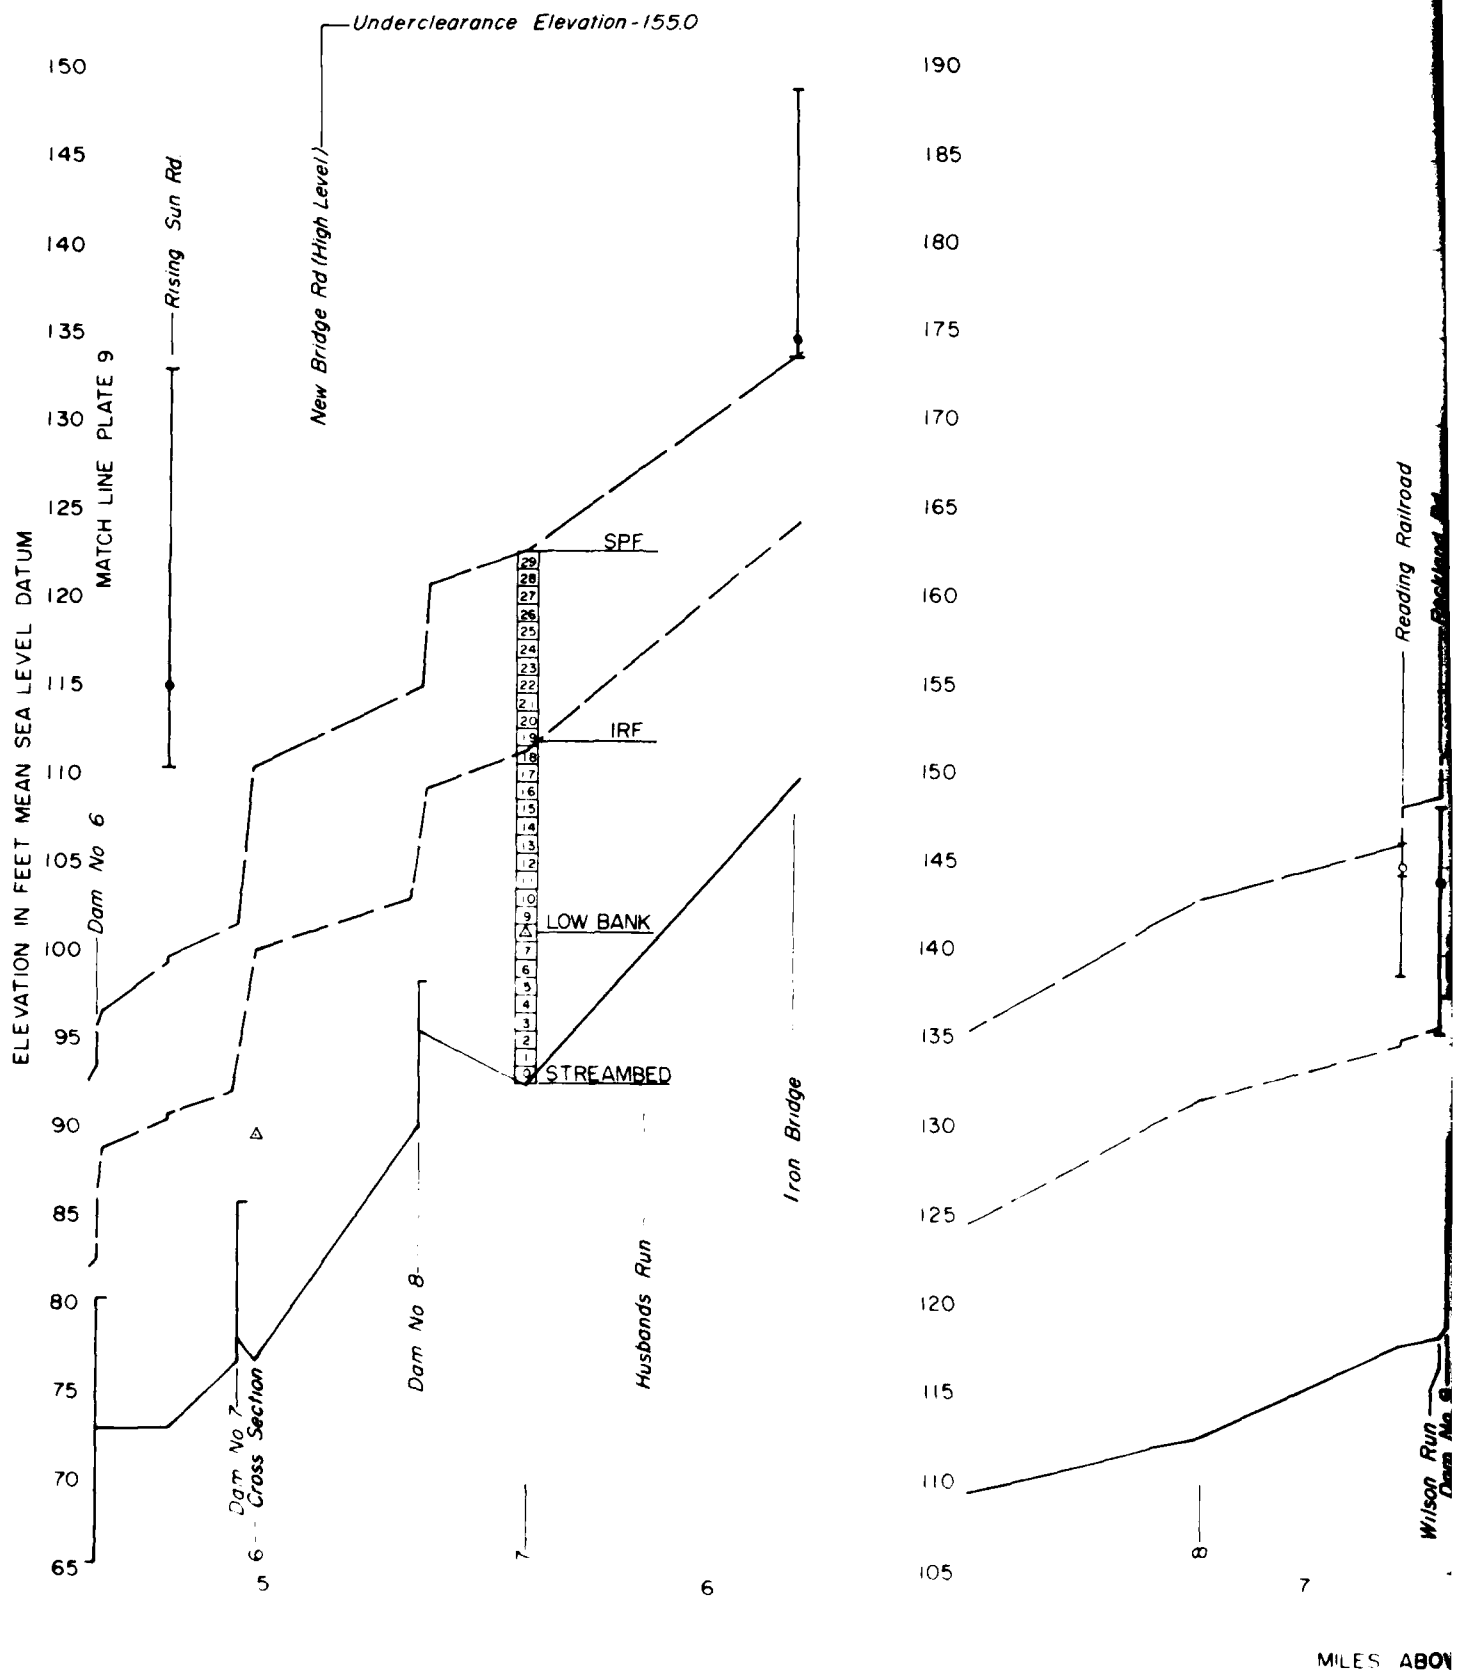
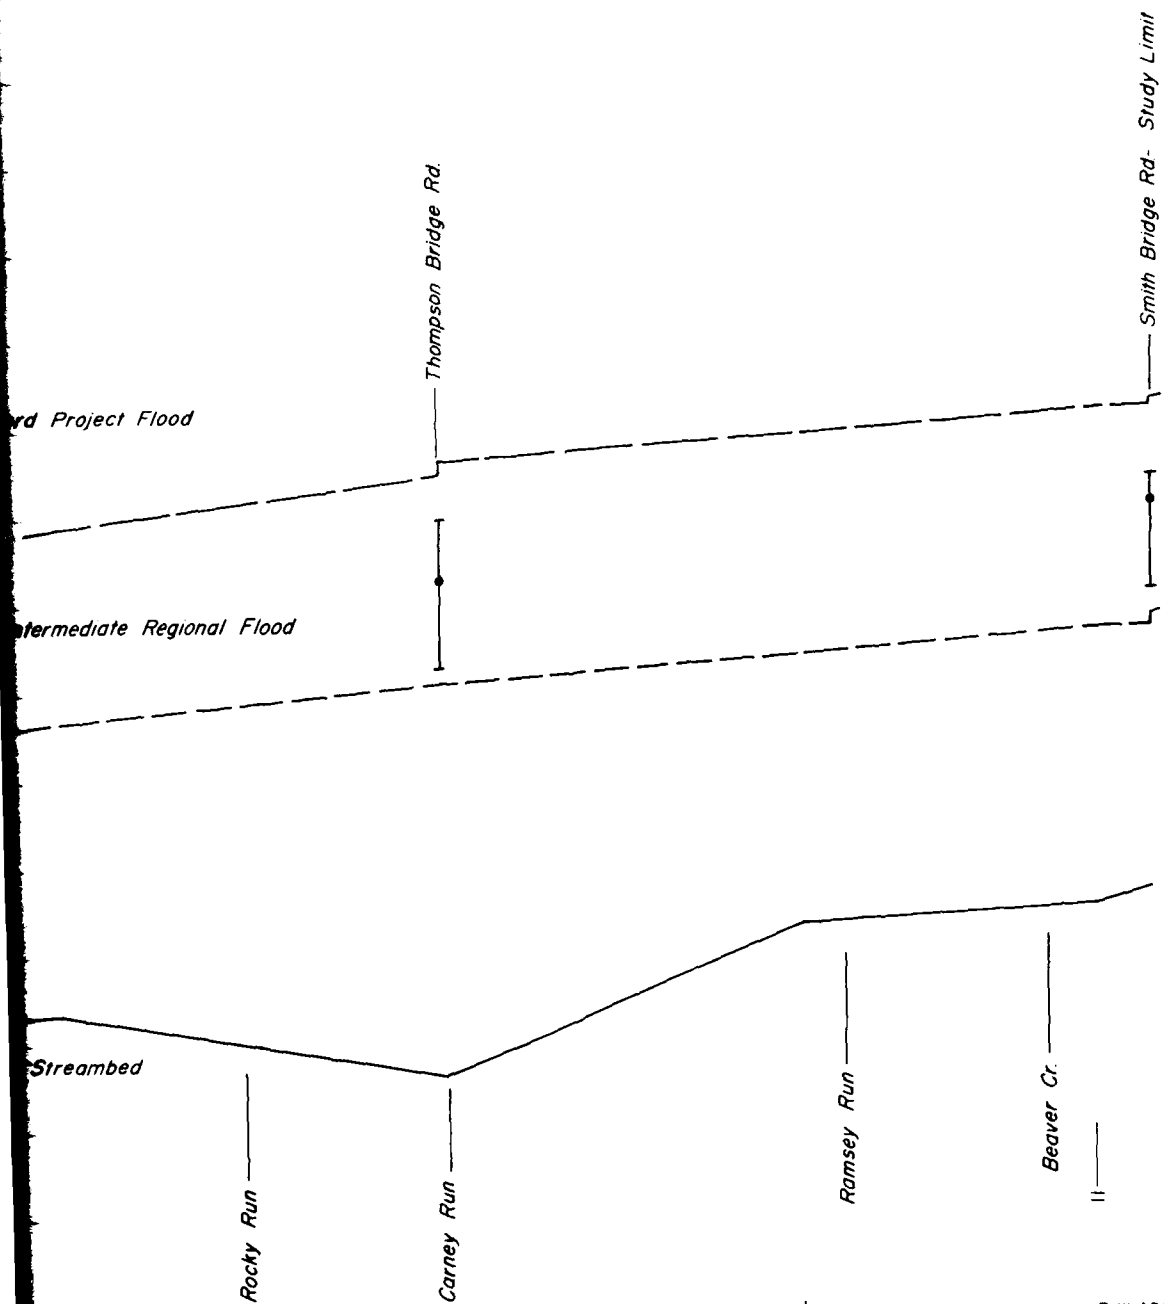
DEPARTMENT OF THE ARMY
PHILADELPHIA DISTRICT, CORPS OF ENGINEERS
PHILADELPHIA, PENNSYLVANIA
FLOOD PLAIN INFORMATION
BRANDYWINE CREEK
NEW CASTLE COUNTY
DELAWARE
HIGH WATER PROFILES
WITH FLOOD CONSERVATION
SERVICE DAMS

Project Flood at Wilmington, Delaware, is shown on Plate 12. The relative water surface elevations for the Intermediate Regional Flood and the Standard Project Flood are shown on Plates 7 and 8. Plates 9 and 10 represent water surface elevations for both floods as modified by all proposed Soil Conservation Service Dams in operation.

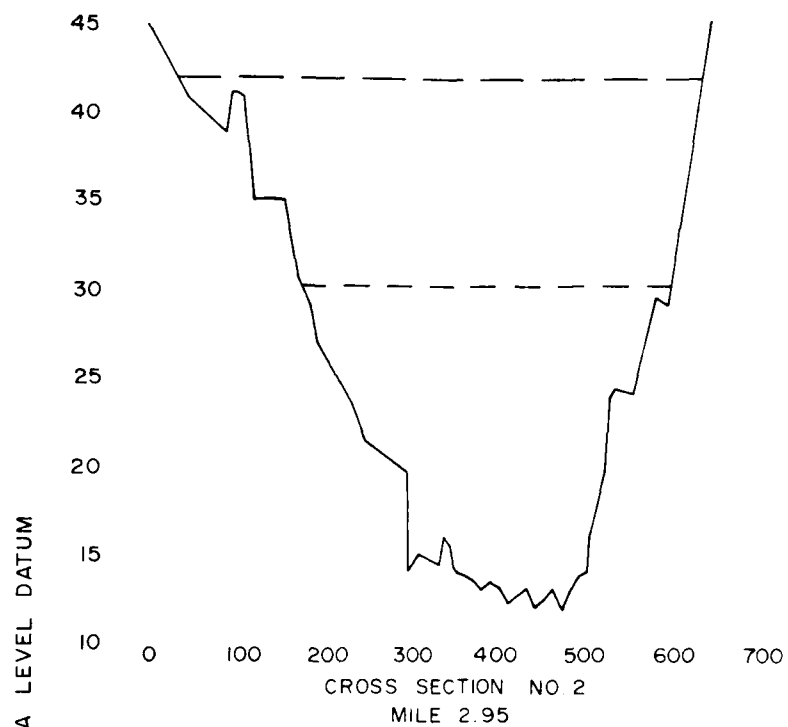
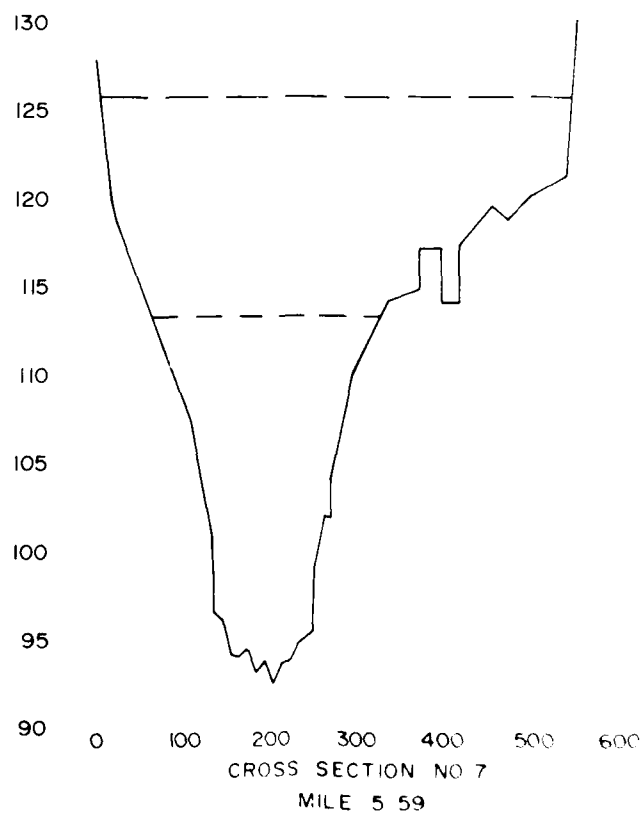
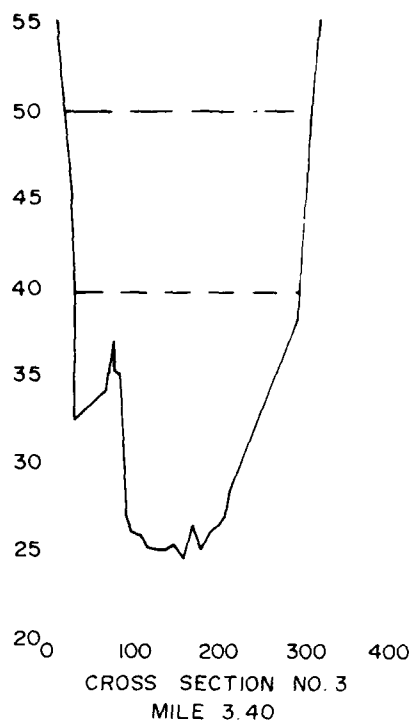
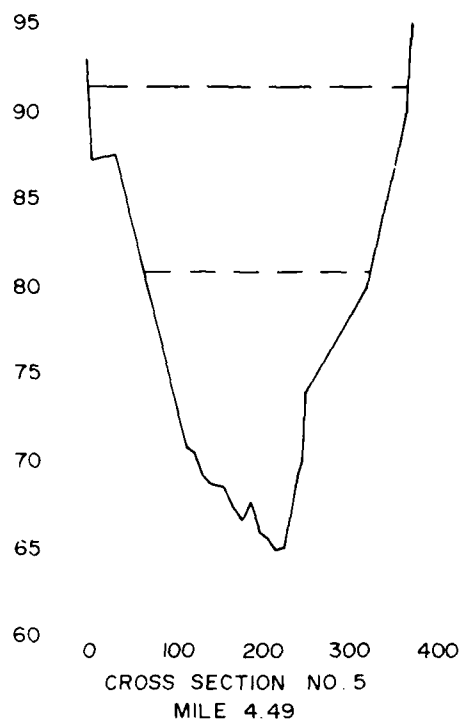
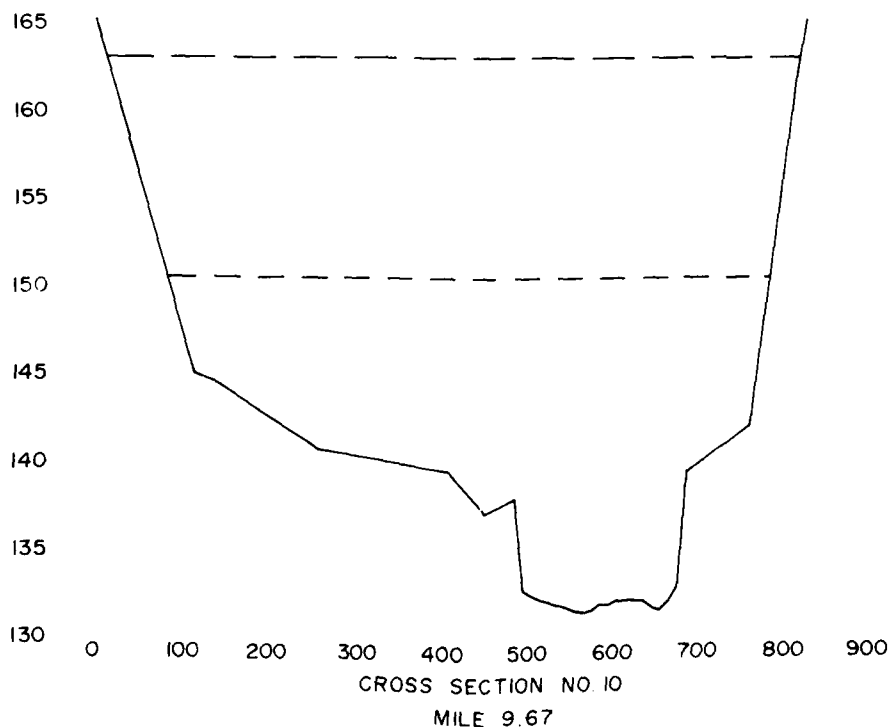
DEPARTMENT OF THE ARMY
PHILADELPHIA DISTRICT, CORPS OF ENGINEERS
PHILADELPHIA, PENNSYLVANIA
FLOOD PLAIN INFORMATION
BRANDYWINE CREEK
NEW CASTLE COUNTY, DEL.
SELECTED CROSS SECTIONS
